## QA/QC Data Ratification Report for the Automatic Urban and Rural Network, April-June 2010

Report produced for the Department for Environment, Food and Rural Affairs, Scottish Government, Welsh Assembly Government and the DoE in Northern Ireland

AEAT/ENV/3082 Issue 1

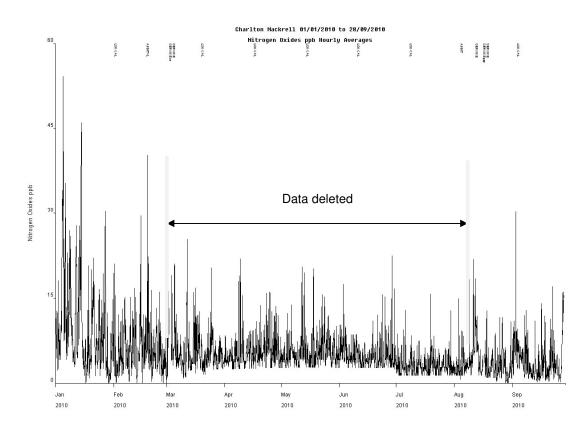
#### Figure 4.1 Charlton Mackrell NOx, Jan-Sept 2010

The NOx analyser response changed at the service on 2 March, which prevented the correct processing top be applied without making  $NO_2$  data negative. This continued up to the service on 16 August. The shift in baseline can be seen in Figure 4.1. No information is available on the nature of the fault.
