**QA/QC Data Ratification Report for
the Automatic Urban Network,
January to June 2002**

AEAT/ENV/R/1281 Issue 1
November 2002

Jane Vallance-Plews

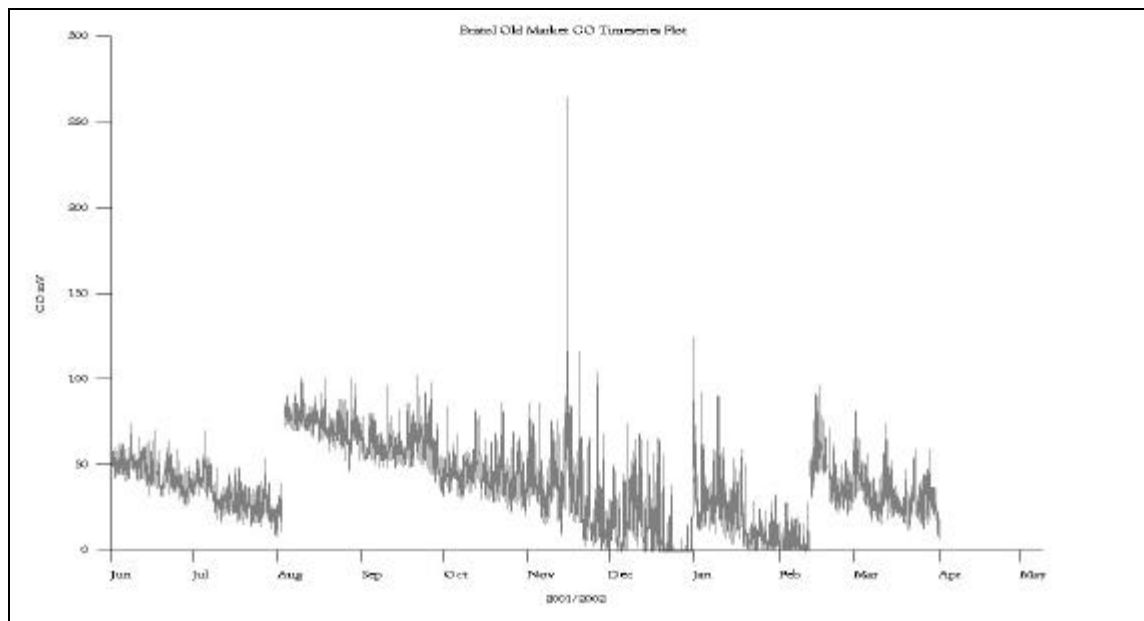
Figure 2.2 CO Instrument Baseline Drift and Zero Truncation at Bristol Old Market (mV)

A problem with zero truncation (also called baseline clipping) was observed with the CO instrument at Bristol Old Market (Figure 2.2) during January and February 2002. This instrument has been regularly adjusted so that the zero is returned to above +50mV. In June 2002 a large offset of 10ppm (200mV) was applied. Over 3 weeks data have been rejected during the period when the output fell below the baseline cut-off. Although

these adjustments were necessary to prevent data loss, adjusting an instrument on a regular basis is generally not recommended.

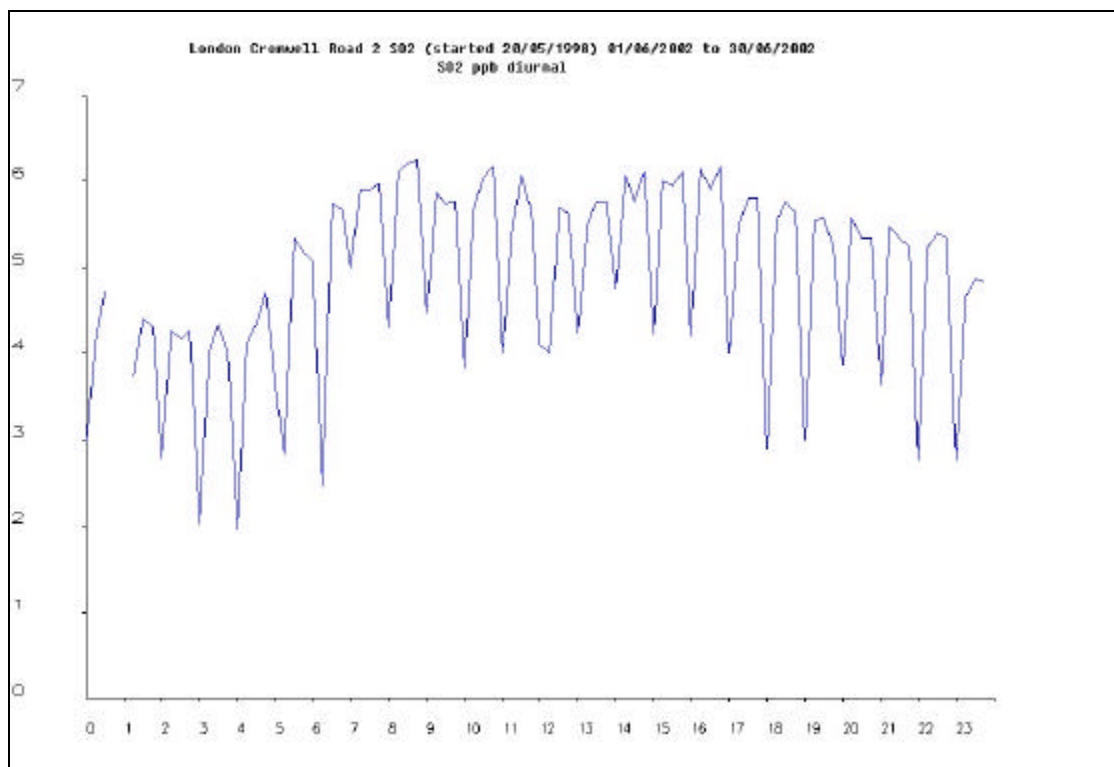
Figure 3.1 London Cromwell Road 2 SO₂ 15-Minute Diurnal Variations

An unusual problem was identified with the SO₂ data from London Cromwell Road. Diurnal plots showed that low 15-minute mean concentrations were being recorded every hour since February 2002 (See Figure 3.1). Investigation by the ESU concluded that the low values were being recorded when the site was being polled every hour. Replacement of the modem did not resolve the problem therefore the logger was replaced on 16th July, which cured the fault. Data were corrected by removing one 15-minute mean value every hour.

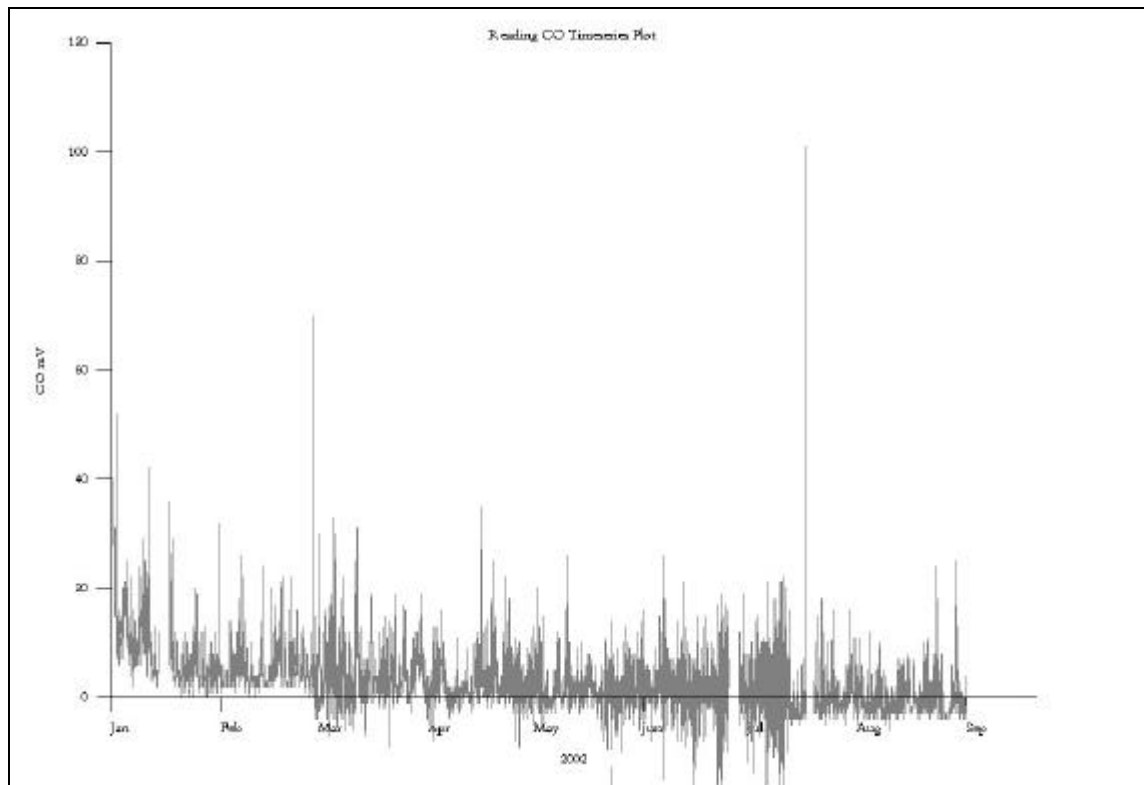
Figure 3.2 Reading CO Excessive Response Noise

Over 3 months of CO data from Reading have been deleted from 1st March to the end of June due to excessive instrument response noise. (Figure 3.2). The ESU visited the site on 12th July and found that the problem was due to the pump vibrating caused by a loose mounting. Once the pump was secured the instrument response improved dramatically.

During routine calibrations LSOs should try to note any excessive noise or vibration from instruments or pumps, as this may have an adverse effect on data quality.

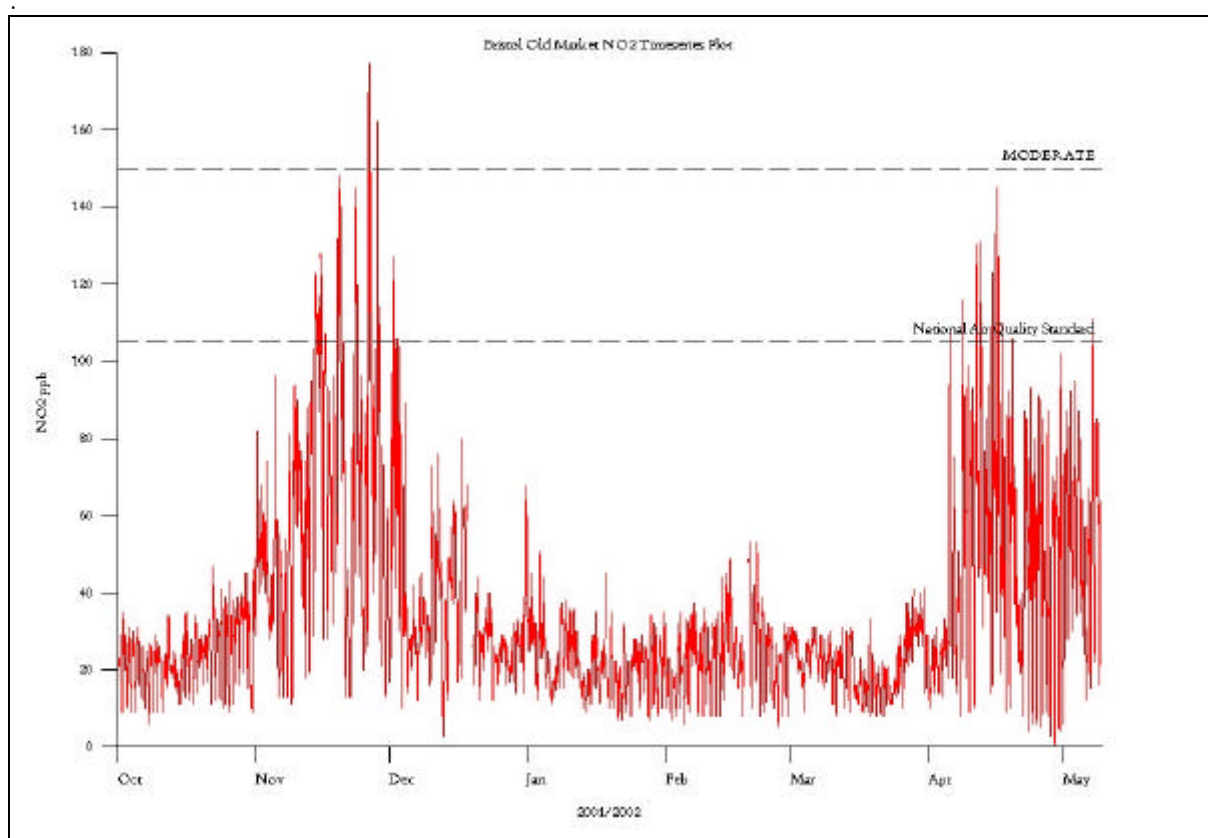
Figure 3.3 High NO₂ Concentrations at Bristol Old Market

The unusually high NO₂ concentrations reported previously at Bristol Old Market site are still under investigation. High levels were recorded in November and December 2001 and at the time no reason could be found to reject the data. However, these high concentrations reoccurred in April 2002 (see Figure 3.3) and QA/QC Unit therefore installed a second NO_x analyser at the site on 26th April to verify the data from the AUN instrument. Results from the duplicate analyser showed concentrations that broadly agreed with the high levels being recorded by the AUN analyser. Further site investigations by QA/QC Unit showed that the flow through the manifold was very low, suggesting a possible obstruction or damage to the manifold. The ESU visited the site on 18th July and repaired a kink in the teflon sample line which was restricting the flow through the analyser. The site has since been relocated to the ground floor with the sample inlet very close to its original location so as not to change the site classification. Although it is likely that the periods of high data were an artefact of the sampling fault, no action has yet been taken to delete the data until a sufficient period of data has been collected from the instrument in its new location.

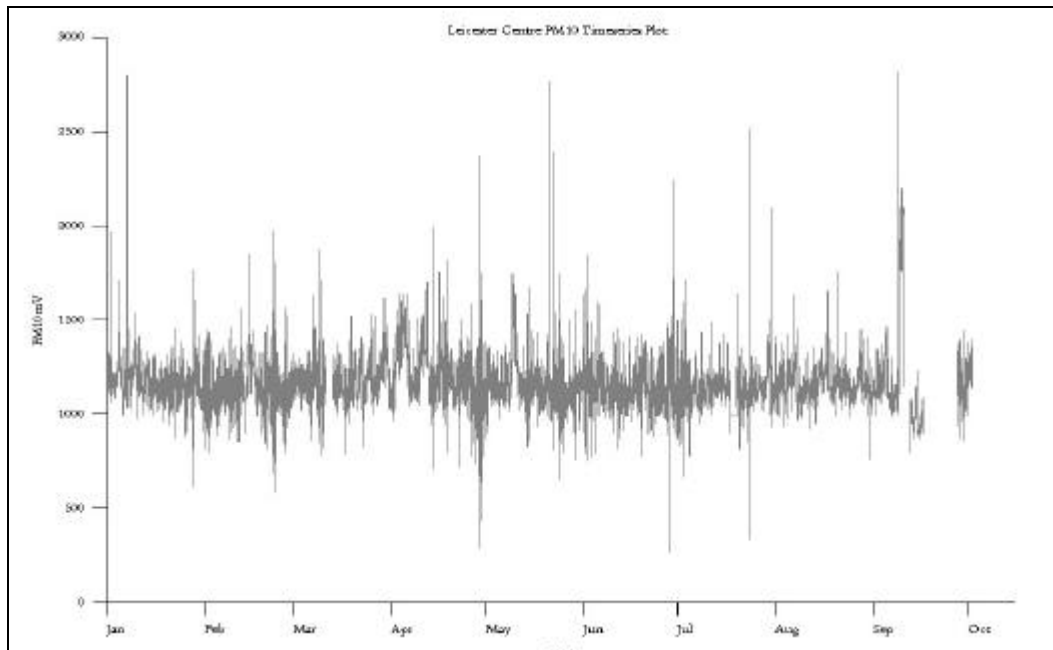
Figure 3.6 Leicester Centre TEOM Response Instability, Jan-Oct 2002

The TEOM analyser at Leicester Centre showed intermittent response instability throughout January to July resulting in a total data loss of over 5 weeks (See Figure 3.6). There were many attempts to repair the fault which was thought to be due to temperature instability. Satisfactory response performance was eventually achieved on 23rd July following the removal of a transit screw located in the sensor unit.
