AEAT/ENV/R/0357

**QA/QC Data Ratification Report for
the Automatic Urban Network,
January - June 2000**

November 2000

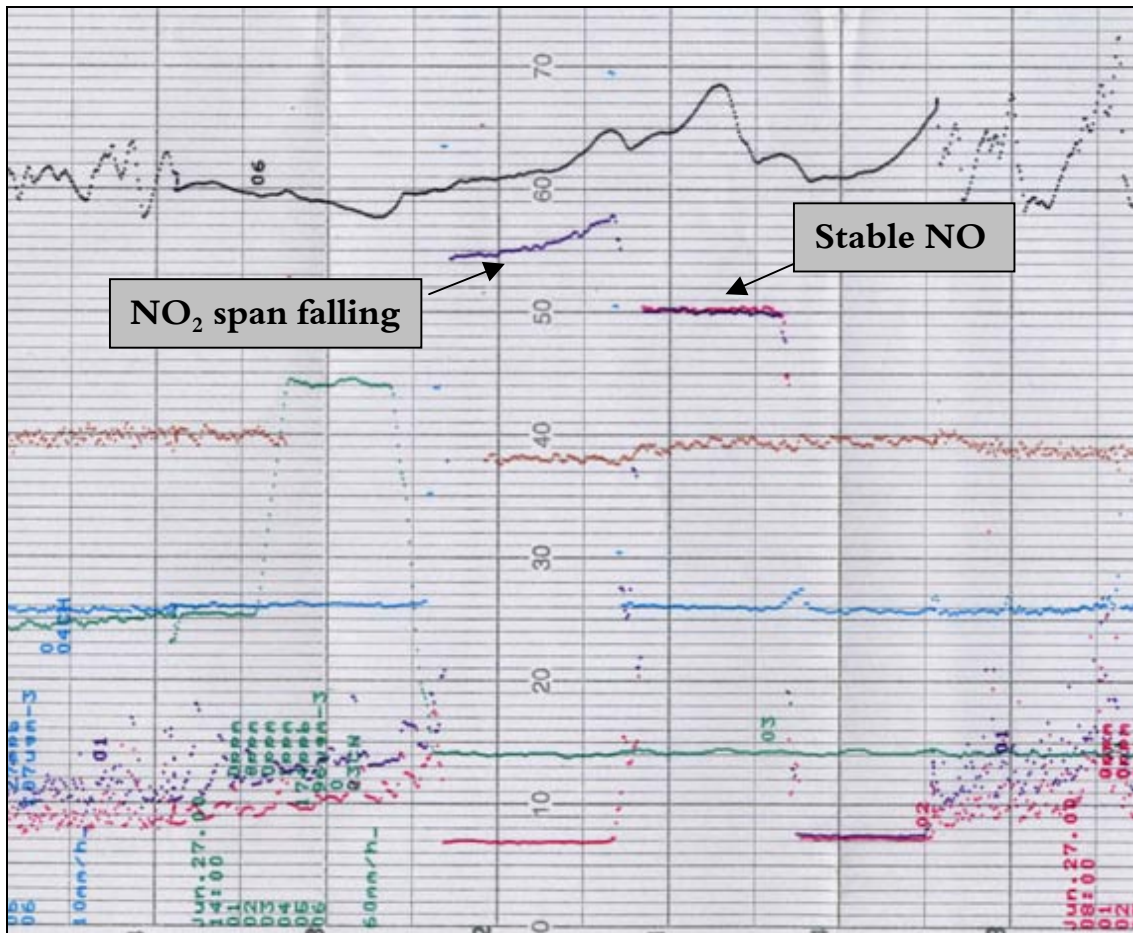
In order to examine the effect of the converter performance on the data quality, QA/QC Unit has looked at the chart records (where available) to examine the calibration response to NO₂ span gas. In some cases, where the converter efficiency is low, a noticeable decline in the response of the NO₂ span can be seen during calibration. (see Figure 2.1).

Figure 2.1 Chart response showing poor NO₂ converter performance

Chart recorder	Examine the NO ₂ trace during the 20-minute span calibration for a steady fall in the response. (see Figure 2.1)
Ambirack Systems	Check the mV response on the calibration screen during the calibration. The Ambirack viewer programme may be used to inspect the calibration response stability. Instructions have been provided by Signal and are given in Appendix C
Data Logger	Record the NO ₂ span response at 2, 5, 10 and 15-minute intervals to see if the response is gradually falling.

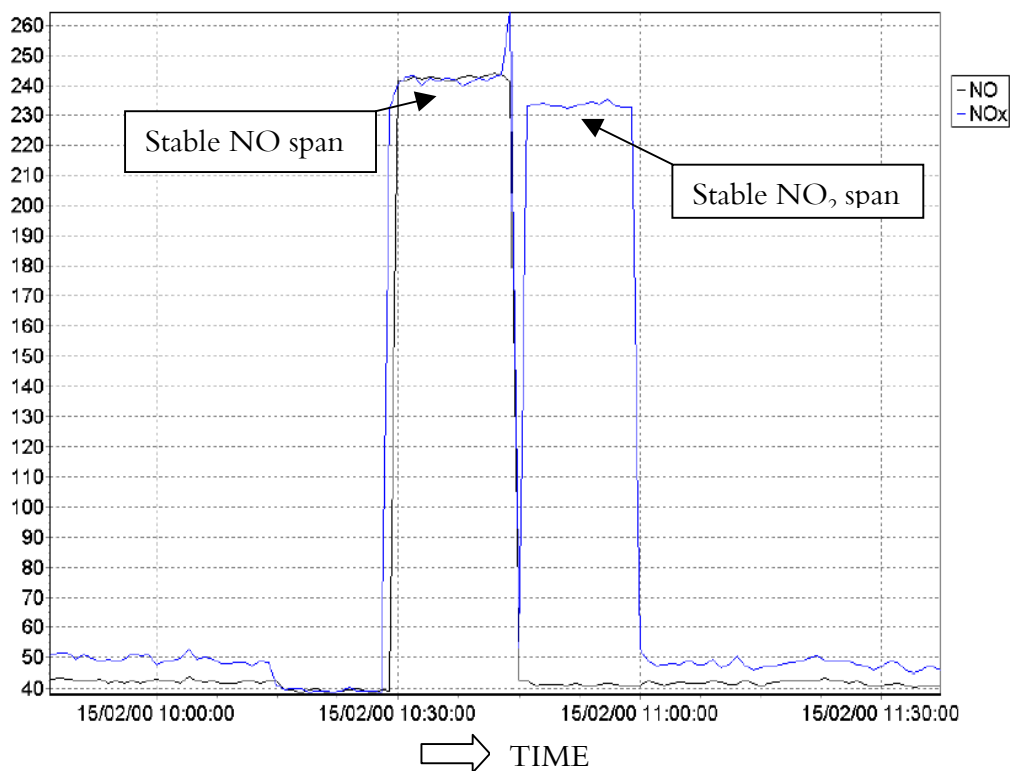
Figure 2.2 Ambiview screen showing satisfactory converter performance

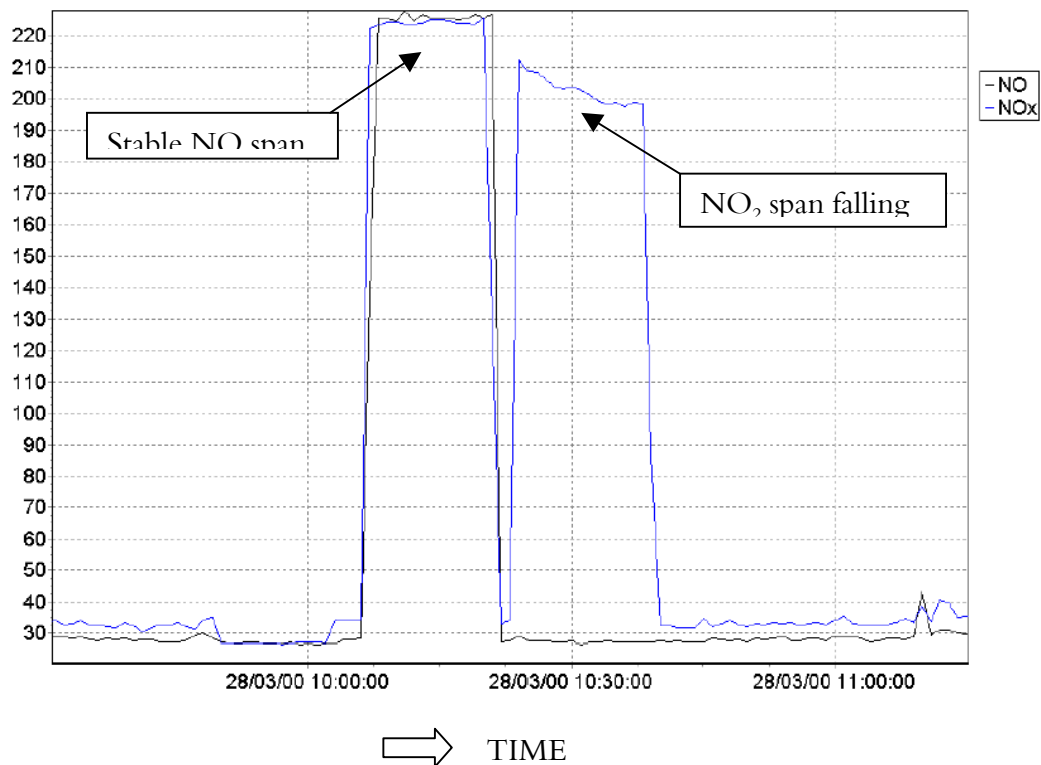
At the sites with Ambirack analysers installed, additional information was provided by the Equipment Support Unit (Signal) to help assess the impact of the converter performance on data quality. Examination of the 1-minute NO₂ calibration data showed stable response when the converter was performing satisfactorily (Figure 2.2). However, a few weeks later a drop in the NO₂ response during the routine calibration can be seen, giving an indication that the converter performance was declining (Figure 2.3).

Figure 2.3 Ambiview screen showing poor converter performance
